PART ONE – COMMUNITY ANALYSIS

A.1 GEOLOGY, TOPOGRAPHY AND SOIL Beryl Allen Dick

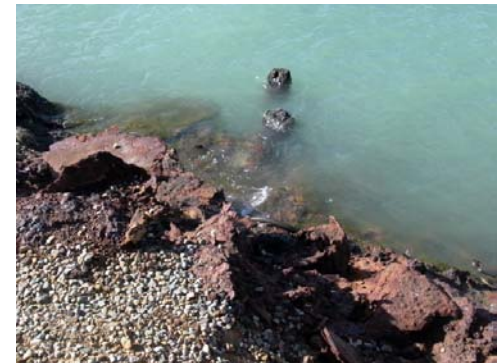
Metal rich waste rock adjacent to Howe Sound, Britannia Beach, September 2003.

Complicating the existing sediment profile is the residue from the mining activities which took place in this area. The metal rich rock removed from Britannia Mountain by tunnelling and open pit mining was processed at the mill to extract the metallic minerals. Waste rock was pulverized and discharged into Britannia Creek and Howe Sound. Britannia creek has overflowed its banks a number of times depositing this waste sediment during each flood event. The crushed waste rock is visible in many areas of the current town site. The sub-economic waste rock contains significant concentrations of copper and zinc minerals, and abundant pyrite, an iron sulphide mineral. Pyrite reacts with oxygen and water to form sulphuric acid, which acidifies rainwater and groundwater. This acidic water leaches metals from the metal rich rocks. The elevated levels of copper, zinc, cadmium and lead in the water are toxic. This acidified groundwater is called acid rock drainage. Acid rock drainage existed prior to mining and will continue despite closing of the mine.⁵

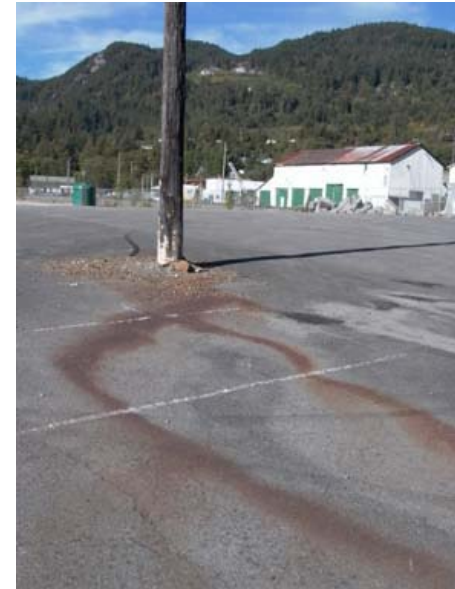
Leaching of metal rich sediments.
Beach front parking lot, Britannia Beach,
September 2003.

The effect of disturbance of surficial contaminated sediments on the metal rich acid rock drainage will need to be assessed. The metal rich sediments discharged into Howe Sound are concentrated in an alluvial fan within 3 km. of the shore but also cover most of the inner basin of Howe Sound. Locally sediment from the Squamish River and local creeks has covered deposited tailings and reduced metal contamination of surface sediments.⁶ Proposals to construct a marina and dock adjacent to Britannia Beach will need to examine the effect sediment disturbance will have on the submerged tailings geochemistry and resulting biological impacts. It is essential that the development proposals for the Britannia Beach area incorporate low impact development methods. The low-impact development approach “combines a hydrologically functional site design with pollution measures to compensate for land development impacts on hydrology and water quality”.⁷ Design parameters for stormwater and rainwater treatment features depend on the existing site hydrology, runoff volumes, peak discharge, frequency and duration of discharge and groundwater recharge as well as proximity to building foundations, space restrictions and importantly in this area, soil and sediment conditions. In the Britannia Beach development area the existence of extensive quantities of mineral-rich rock and sediment will be a very important factor in determining what environmentally sensitive low-impact development approach to take.

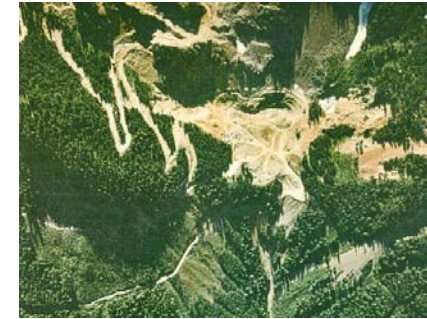
Arial View of Open Pit Complex
 •from Price et al 1995•

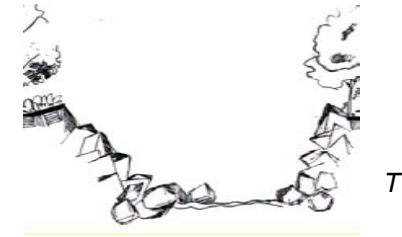
The Current Stream Situation is hard and channelized.

- Vegetation – The lower reach of Britannia creek is presently lacking sufficient streamside vegetation. The creek banks are too steep to allow for soil and vegetation to grow, and the banks are filled with pipe outlets creating point source pollution and erosion. Additionally, the natural curvilinear flow of the creek is disrupted and forced through a straight channel. This disturbs sediment flows and increase flood flow velocities. Valuable streamside wildlife habitat has been lost and connections to other habitat types severed.
