# TECHNICAL BULLETIN

JAMES TAYLOR CHAIR  
IN LANDSCAPE &  
LIVEABLE ENVIRONMENTS

No.5  
October 2000

## Case Study: Brookwood, Township of Langley, BC alternative stormwater management

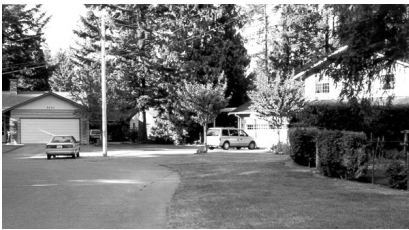
Figure 5-1 - This system provides for two-way residential traffic, and a grassy or gravel shoulder that is constructed to allow for infiltration.

The residential area consists of single detached houses on a grid lot pattern. The streets in Brookwood drain to shallow grass swales at either side of the paved roadway. To maximize infiltration, a continuous length of perforated pipe is aligned below these grass swales. The perforated pipes are embedded within an infiltration trench composed of crushed gravel, and underlain with a layer of filter cloth as shown in Figure 5-2 and 5-3. Runoff infiltrates through the surface of the grass swale and continues to move through the underlying soil to eventually recharge the ground water. Overflow is directed along the surface of the swale and through the

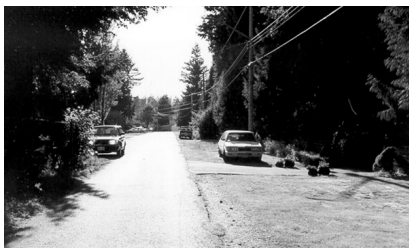
**Best Management Practices**  
BMPS, such as infiltration swales and trenches, are one of the most effective ways to deal with non-point source pollution.
